Macrophyte Survey in Western Springs Lake, Auckland to monitor the effect of Grass Carp.

First Survey, 21 October 1996

Macrophyte Survey in Western Springs Lake, Auckland to monitor the effect of Grass Carp

Sixteenth Survey, 2 September 2010

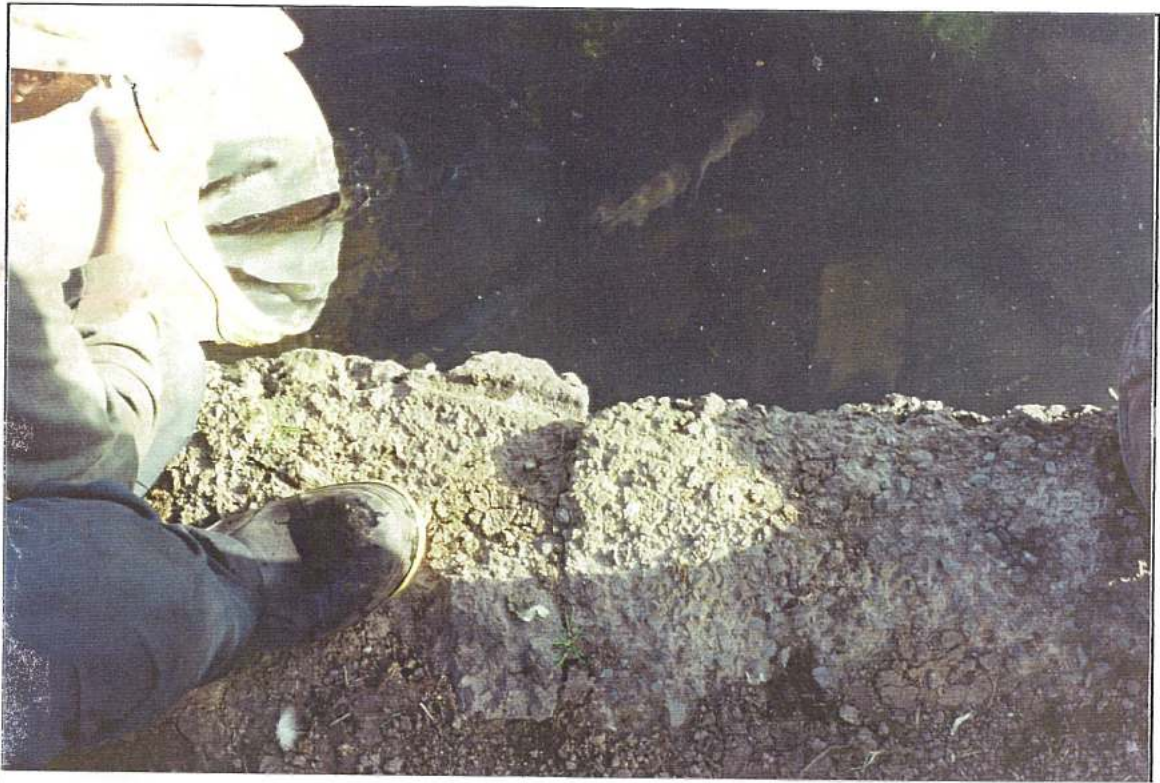
Grass carp being released into Western Springs Lake on 30 September 1996.

Two stockings of grass carp have occurred. The main release occurred on 30 September 1996 following an approval from the Minister of Fisheries when 1001 small grass carp were released (see photograph 1). The first release of three large carp into the Lake occurred three weeks earlier following an approval from the Minister of Conservation. The Park staff have noticed more small stalks of weed floating in the Lake and reported seeing two dead fish with wounds to the back of the head as a result of shags taking the fish. During the survey, sightings of the larger carp were made, but none of the smaller fish.

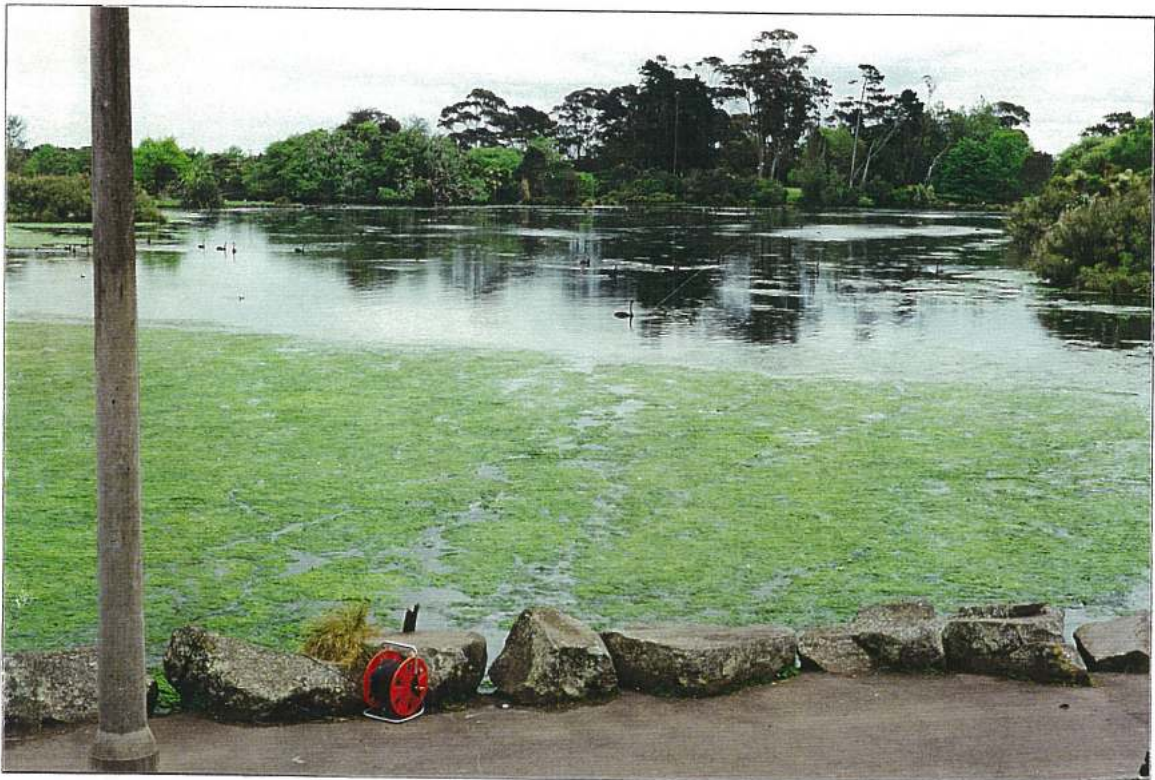
The transect line across the length of the Lake (taken from the Southern end).

For the transect along the length of the Lake, the starting point was at the northern end of the lake where the transect lines was tied to a tree stump close to the water's edge. The transect crossed the Lake to the southern end to a point next to a lamp post and tied onto a large boulder (see photograph 2).

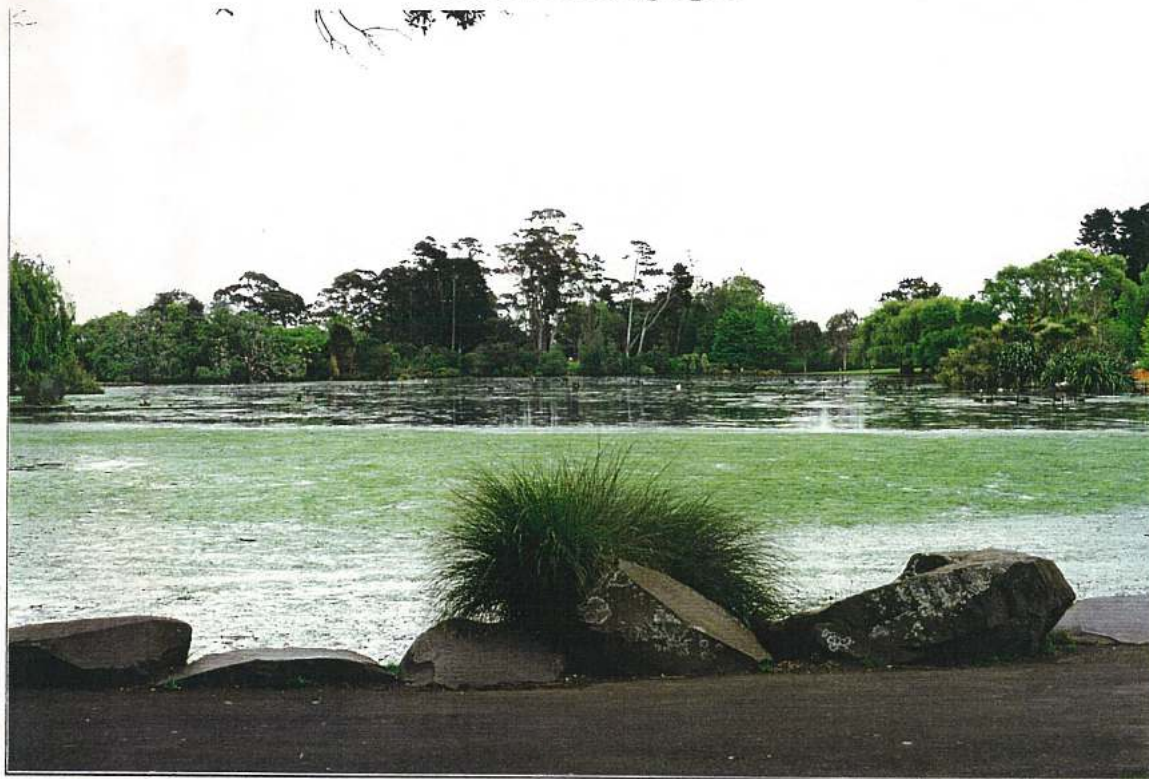
Reference Photograph 1: Southern end by transformer. Note extensive mats of filamentous algae.

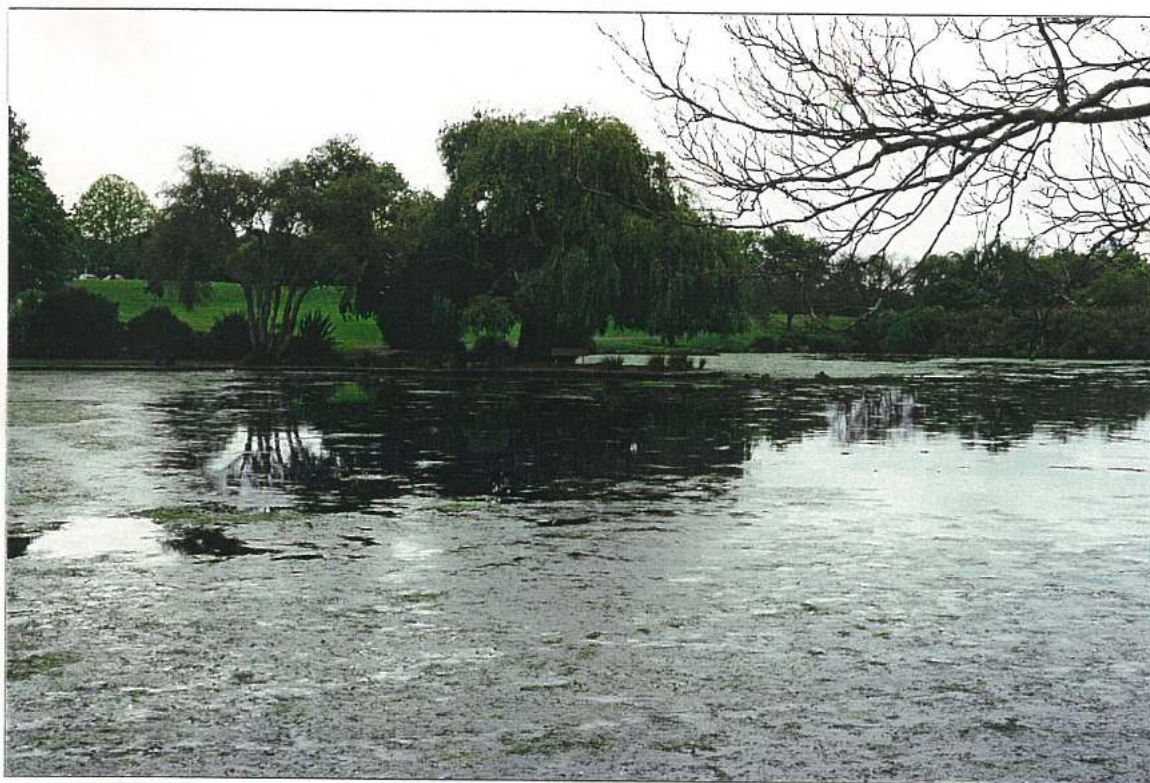
Reference photograph 2: on bridge over larger outlet. The filamentous algae can be seen in the foreground and in the next bay.

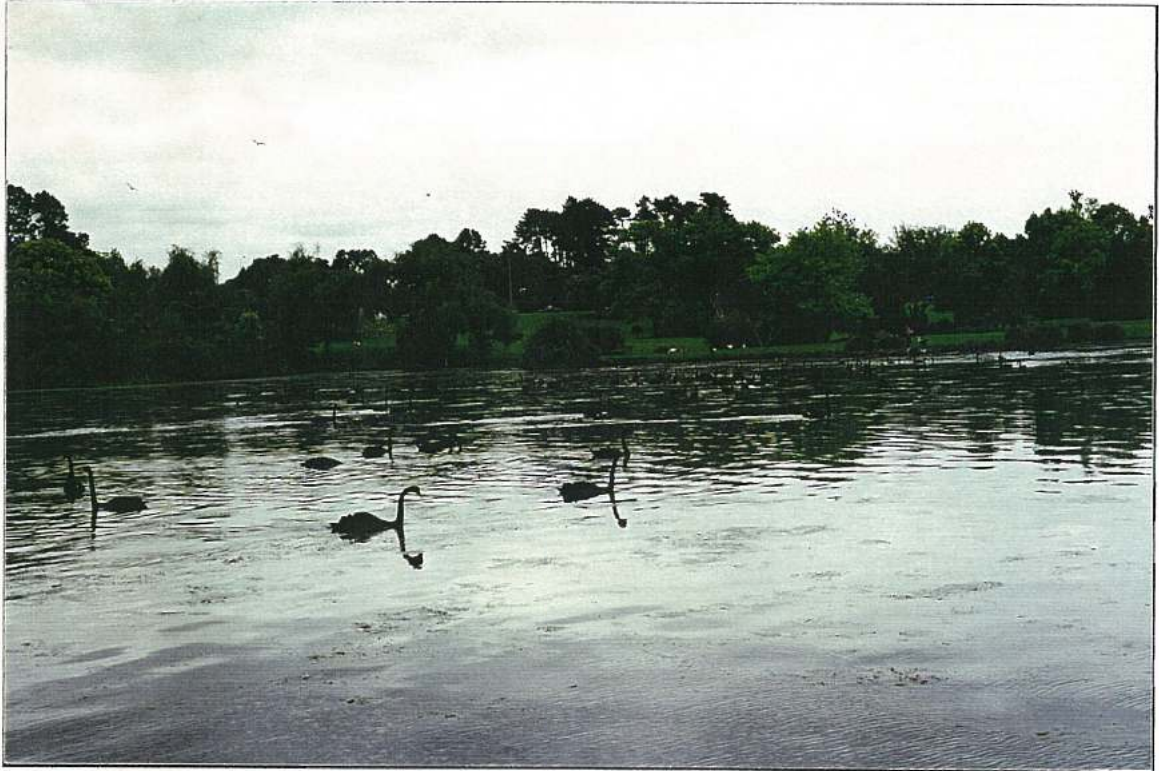
Reference photograph 3: At post by boat ramp. Some of the oxygen weed can be seen reaching the surface.

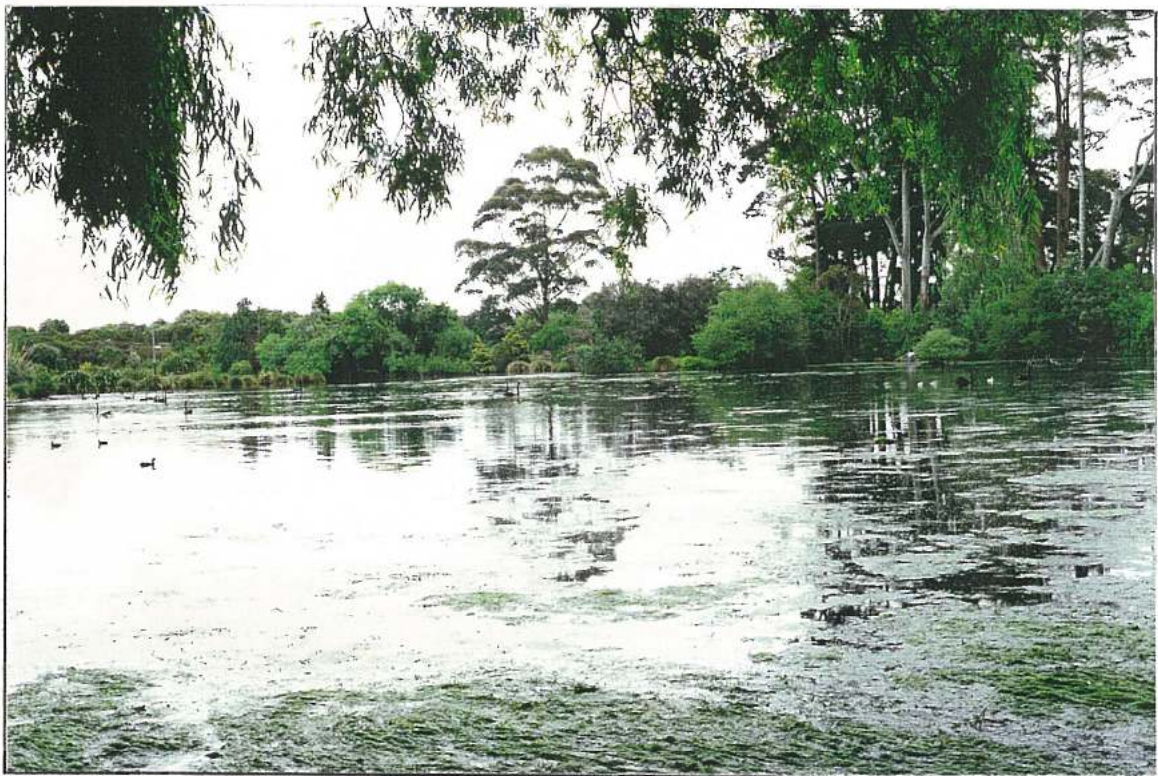
Reference Photograph 4: By small outlet. Filamentous algae visible in the foreground.

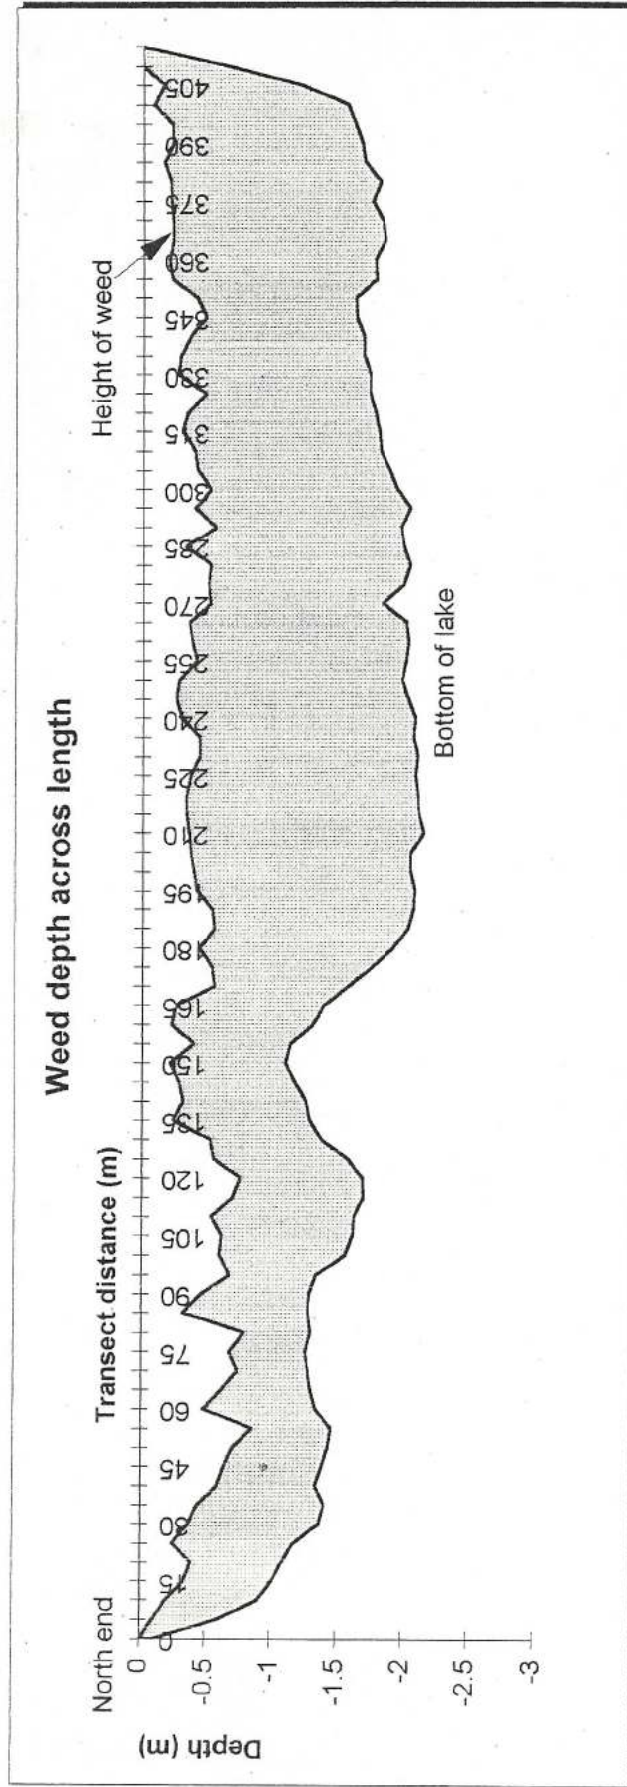
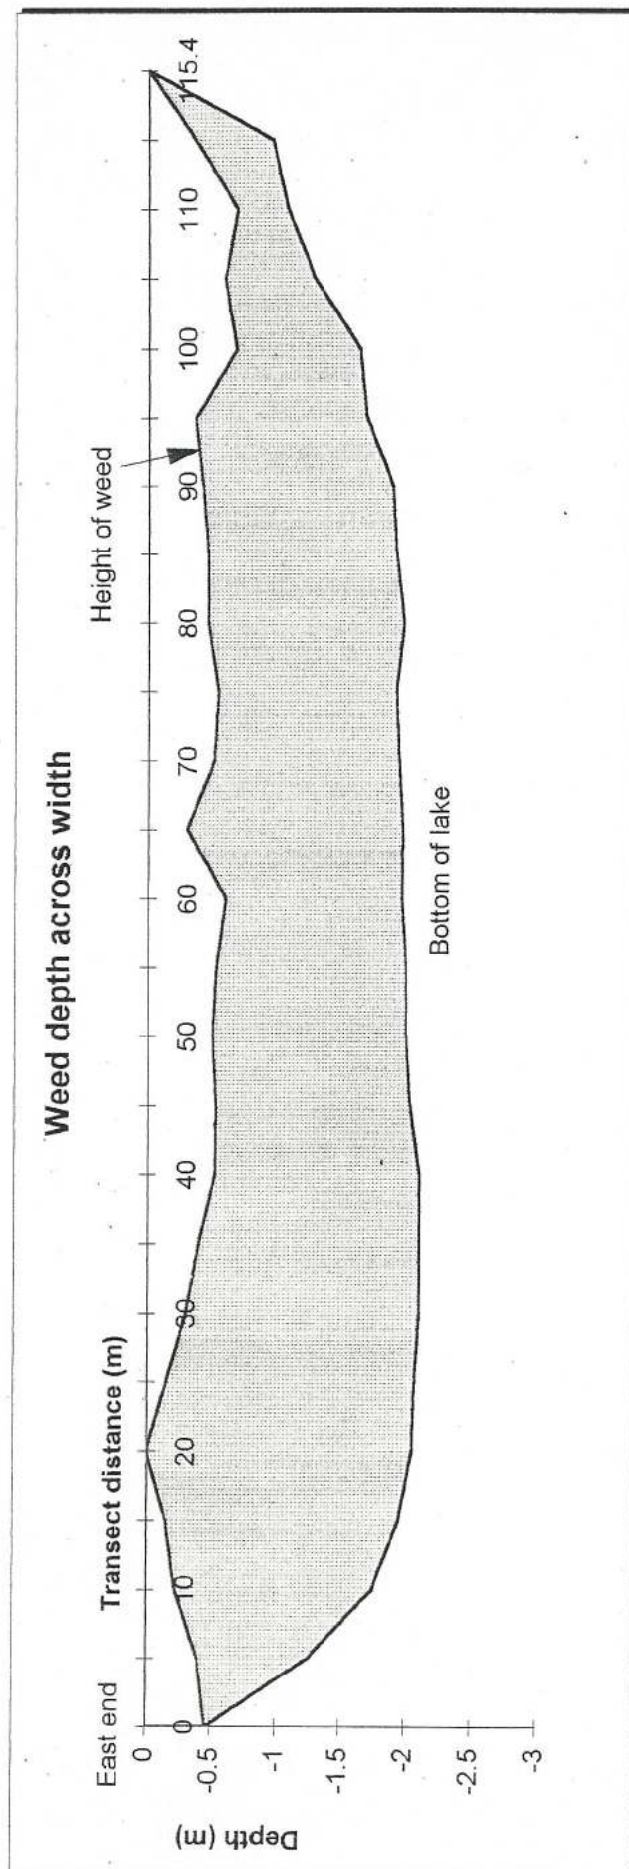
The diagrams on pages 8 and 9 provide a pictorial representation of the macrophyte area for each transect. Note that the scale used for transect distances and depth are not the same. This is to provide a better picture of the macrophyte levels.

For the lengthwise transect (which was 410.55 metres long), total area under the transect to the bottom is 671.2 square metres. The macrophyte area covered 504.7 square metres of this area. This means that 75.2% of the total area under the transect to the bottom contains macrophytes (excluding floating material). For each 5 metre section, the mean weed area was 74.6(±12) %.

For the widthwise transect (which was 115.4 metres long), total area under the transect is 207.1 square metres and the total macrophyte area is 158.5 square metres. This means that 76.5% of the total area under the transect to the bottom contains macrophytes (excluding floating material). For each 5 metre section, the mean weed area was 73.9(± 13) %.

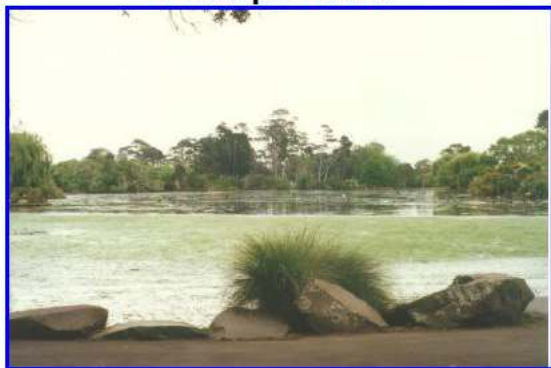
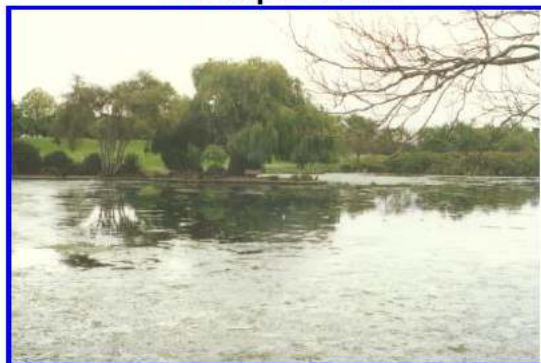
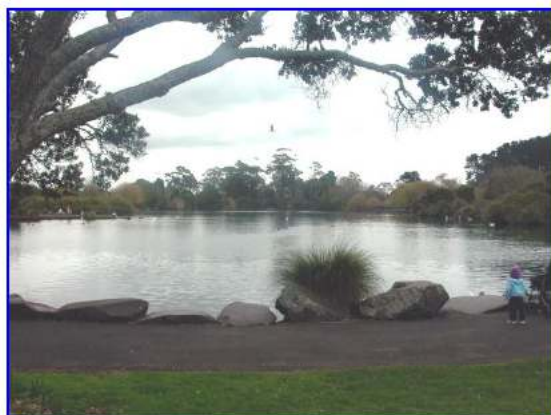
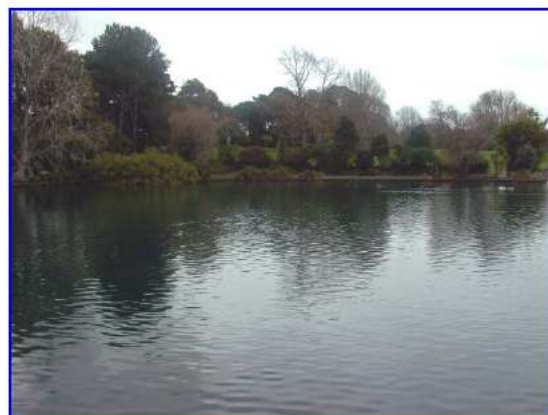
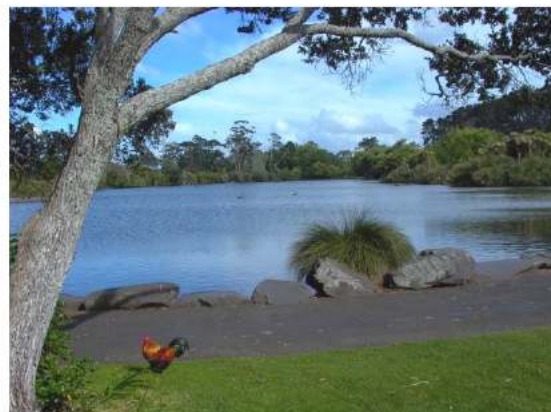
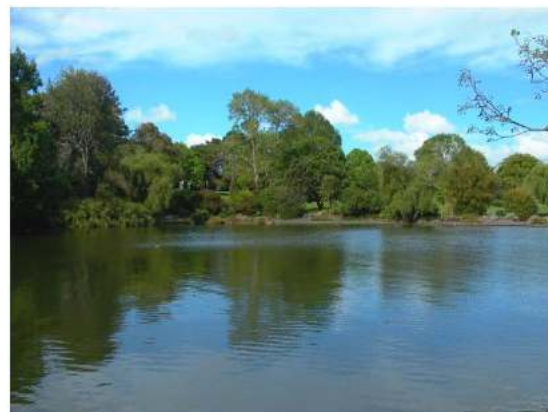
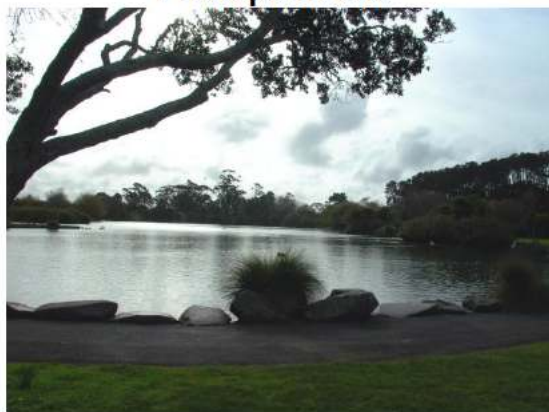
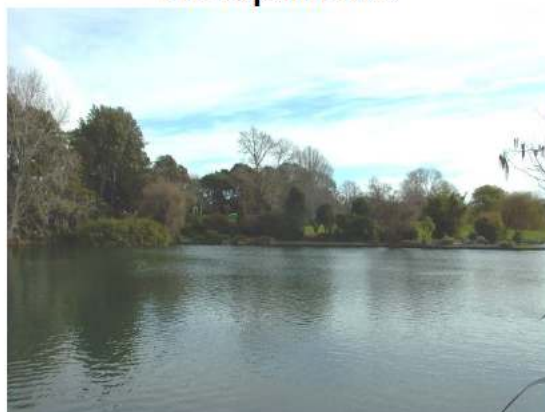
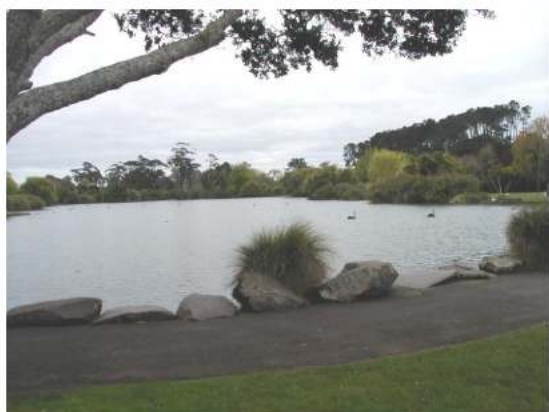
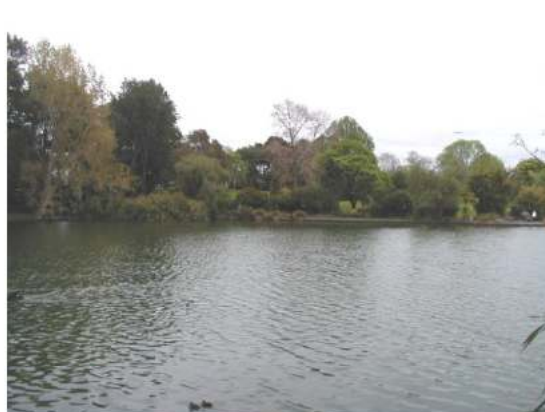
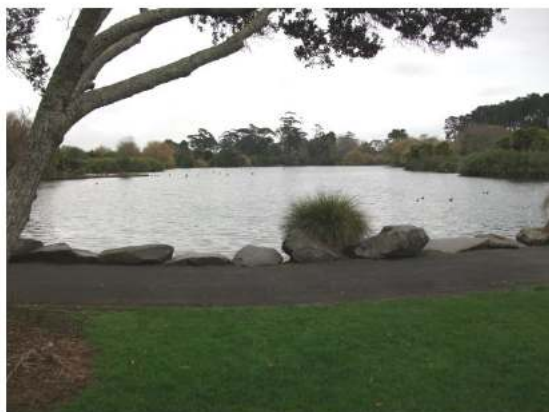
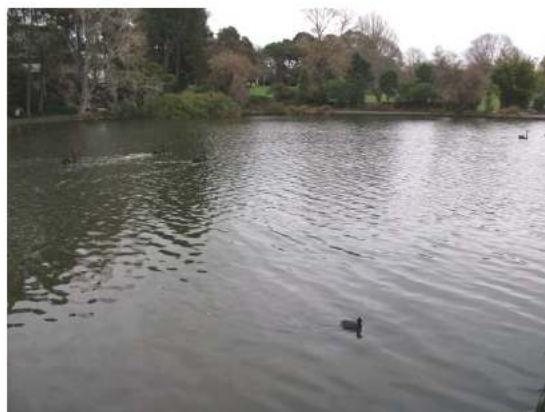
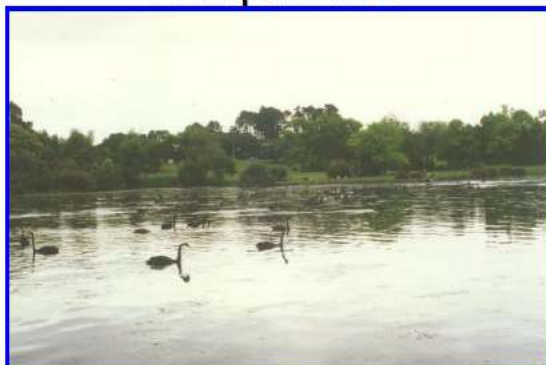
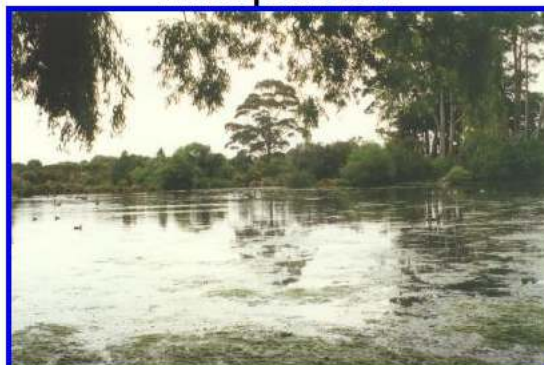
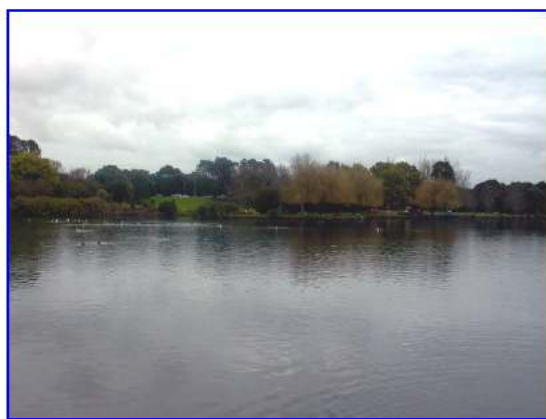
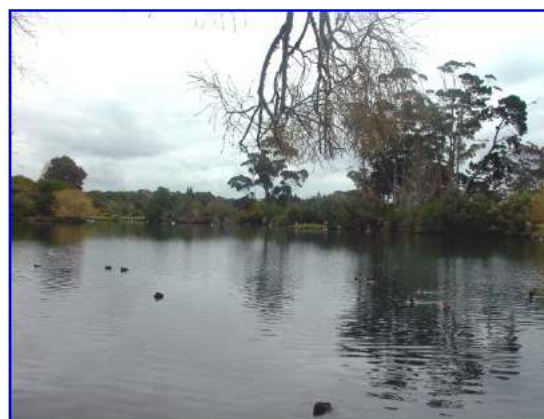
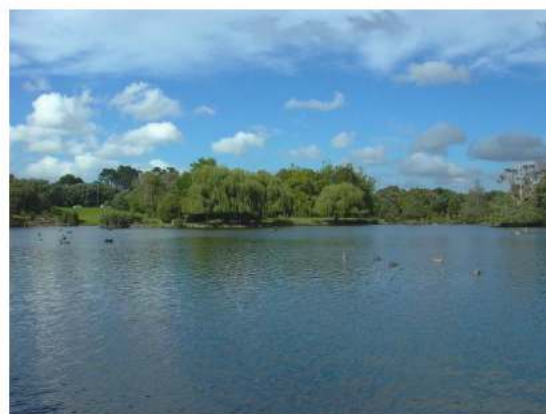
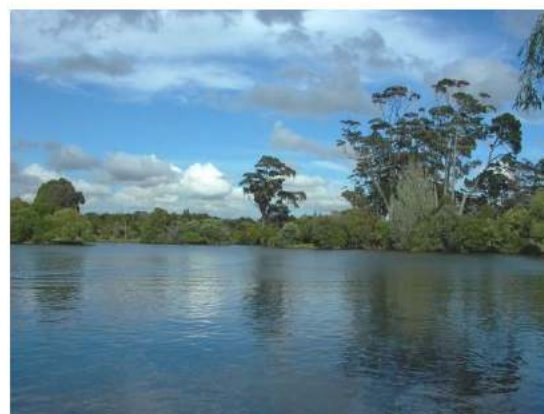
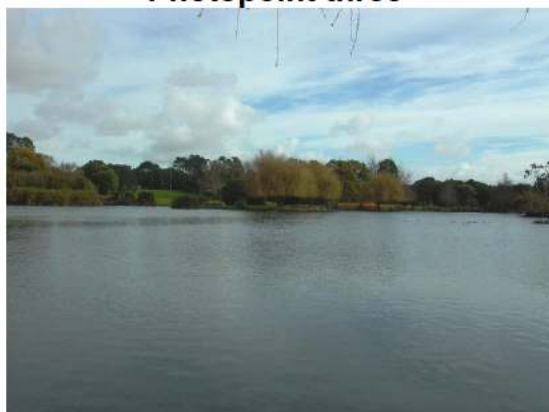
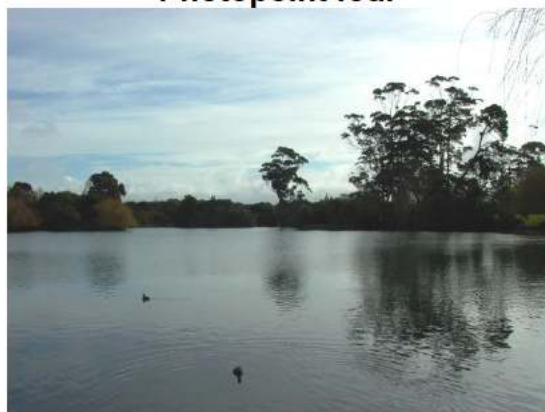
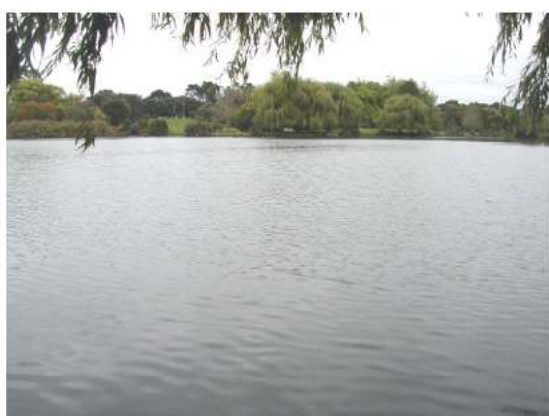
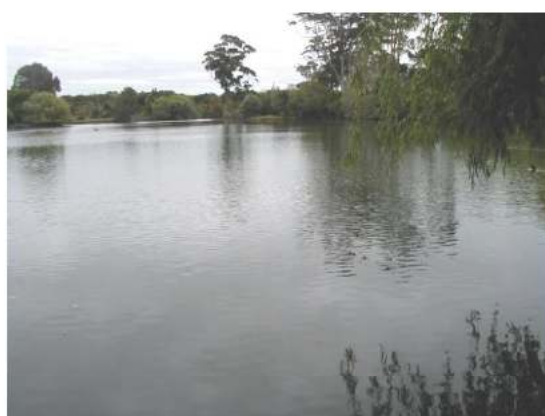
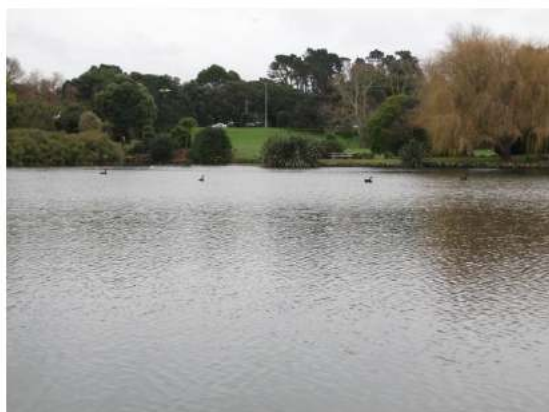
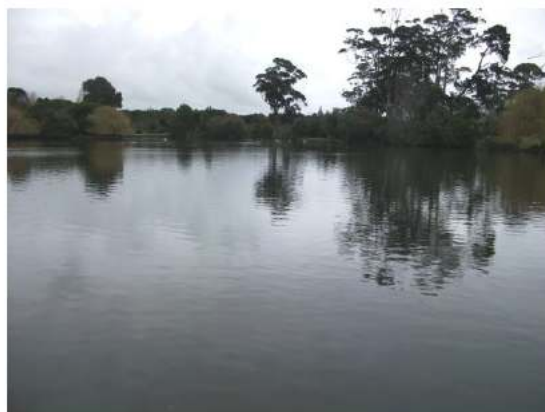
Photopoints (Page 1)

The photographs taken at photopoints for surveys 1, 12, 13, 14, 15 and 16 are presented on pages 14 to 17. The photographs taken during the first survey show macrophytes reaching the surface and extensive mats of filamentous algae floating on the water surface. Since the release of grass carp into the lake, this has not occurred again except to a small degree when survey seven was undertaken.

The four sites identified during the first survey for reference photographs (referred to as photopoints) were located. Photographs of the lake were taken in the same direction as the reference photographs for previous surveys. These photographs were taken to show the change in the level of surface-reaching macrophytes (if any) in the lake in addition to the results from the transect lines. The photographs from survey one, the last three surveys and this survey are presented from page 14 onwards. Photopoints for other surveys are presented in previous survey reports.

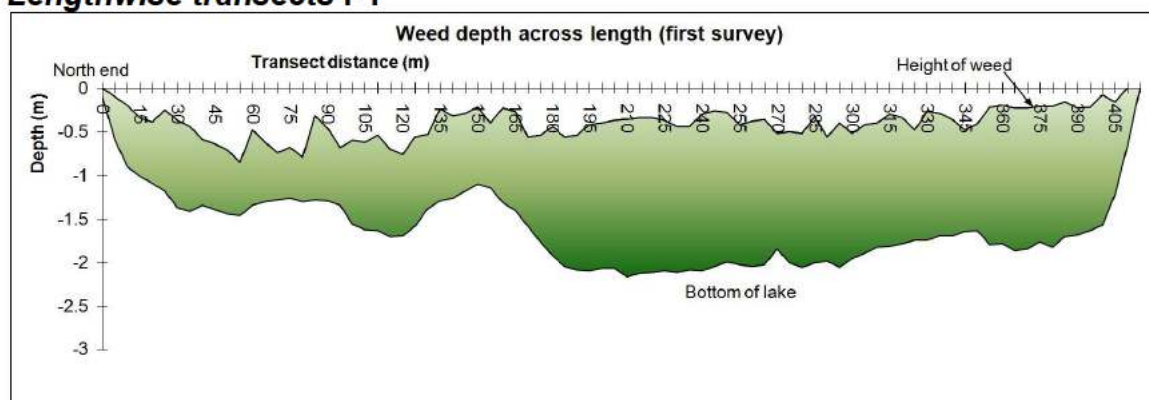
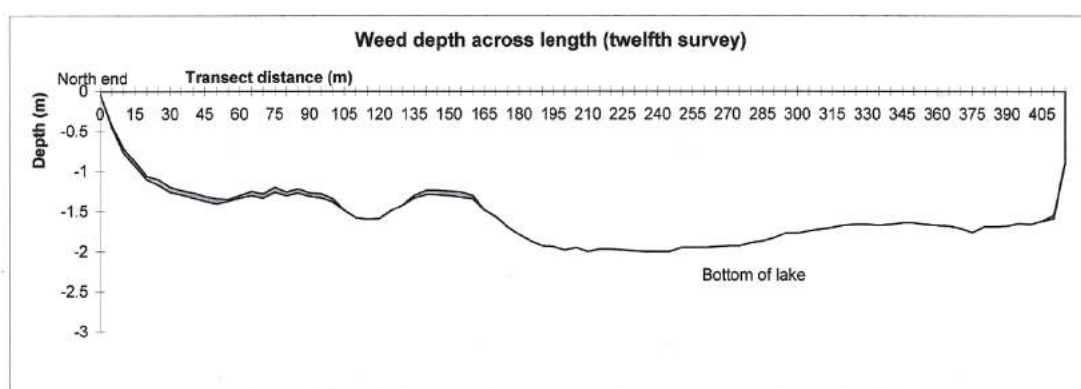
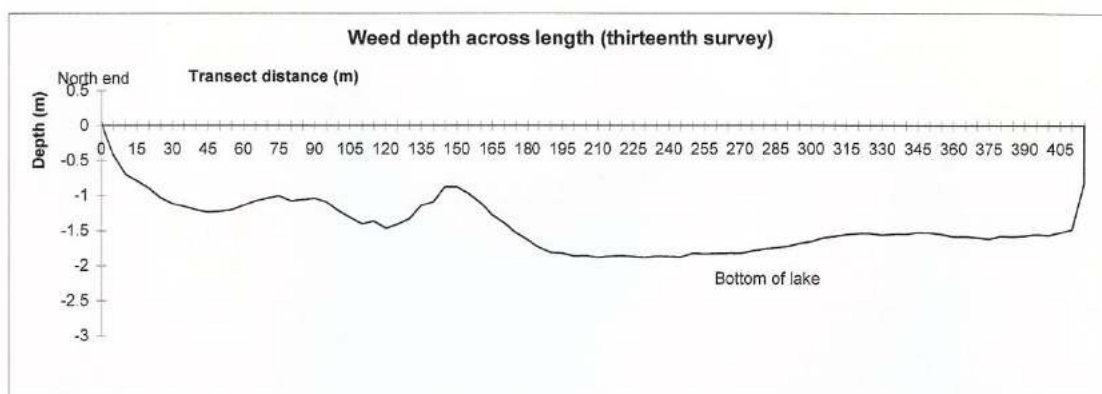
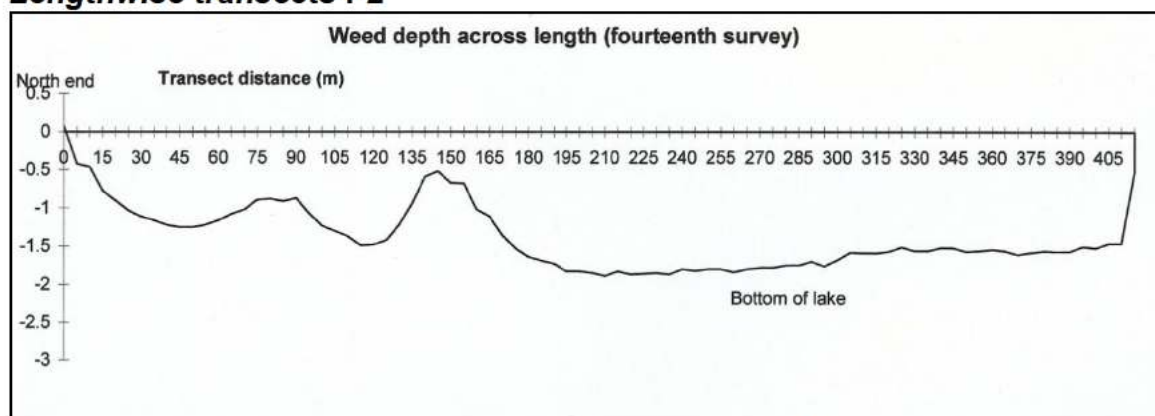
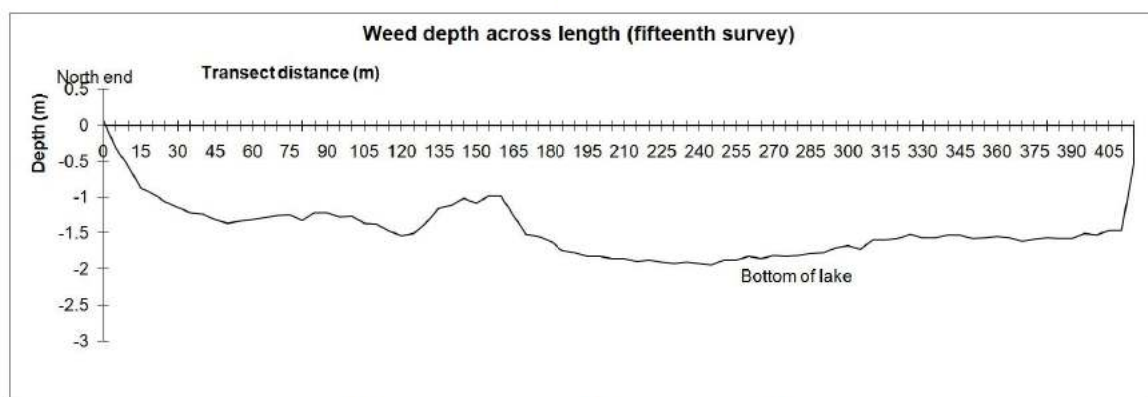
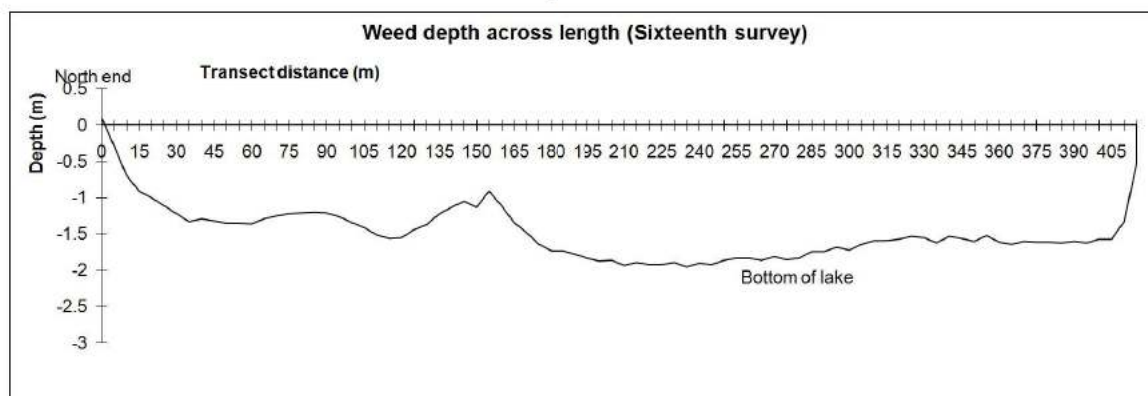
Lengthwise transects P1

These graphs show the level of aquatic plants below the transect lines in the ponds. The x-axis is the distance along the surface of the pond (in metres) from the start of the transect line. The y-axis is the water depth. The shaded or green portion is the area the weed comprises. Where the shaded portion reaches the x-axis, the weed is reaching the surface. If there is no shading present, there is either no weed present, or the level is too small to register in the graph.

The diagrams on pages 18-21 provide a pictorial representation of the macrophyte area for each transect for the first survey and the last three surveys as well as this survey (the diagrams for previous transects can be seen in previous reports). Note that the scale used for transect distances and depths are not the same for the lengthwise and widthwise transects. This is to provide a better picture of the macrophyte levels. Where the area under the transect diagram is clear, it means there is no weed present or there is insufficient weed to show on the graph.
